# Truckee Canal Failure on 5 January 2008

## Investigative Evaluation Report

March 2008

U.S. Department of the Interior  
Bureau of Reclamation  
Mid-Pacific Region  
Sacramento, California

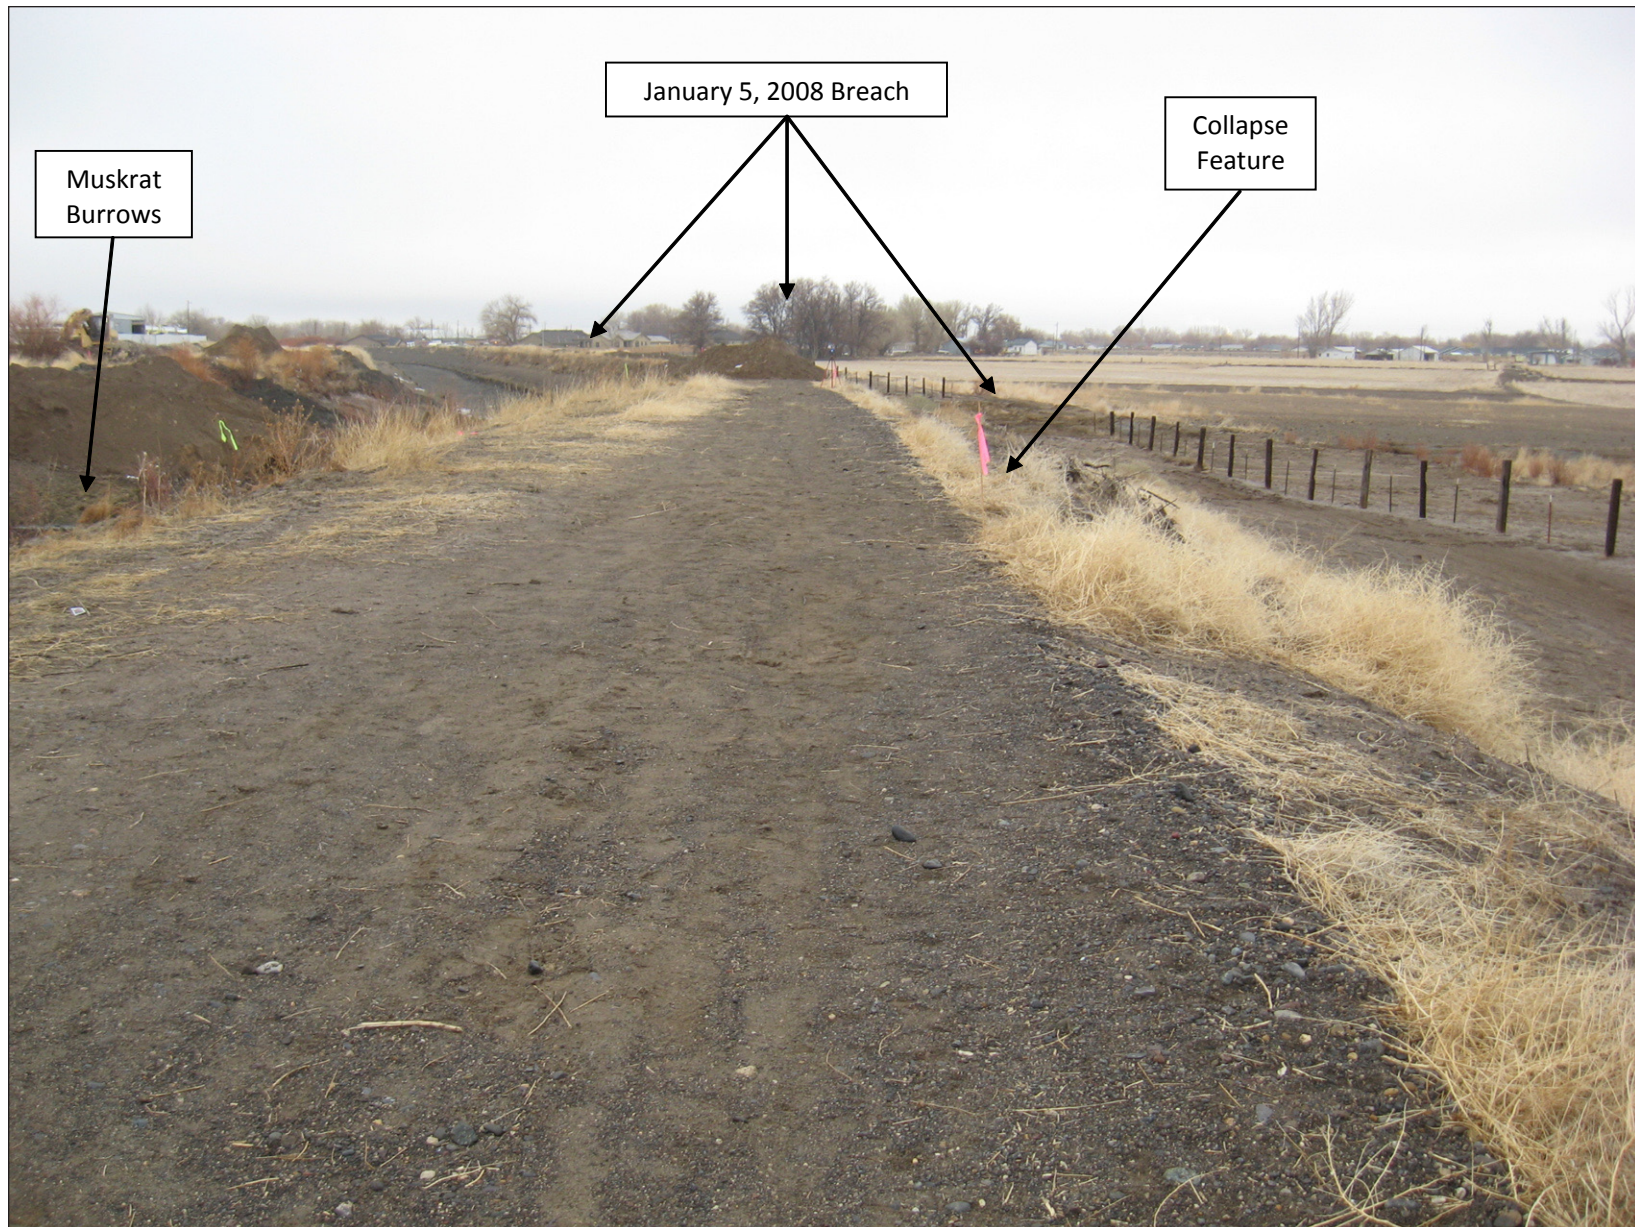
Photo 11. Left canal embankment looking downstream, showing relative locations of collapse feature (right), muskrat burrows (left), and breach (top center). Photo by M. McCulla, 01-13-2008.

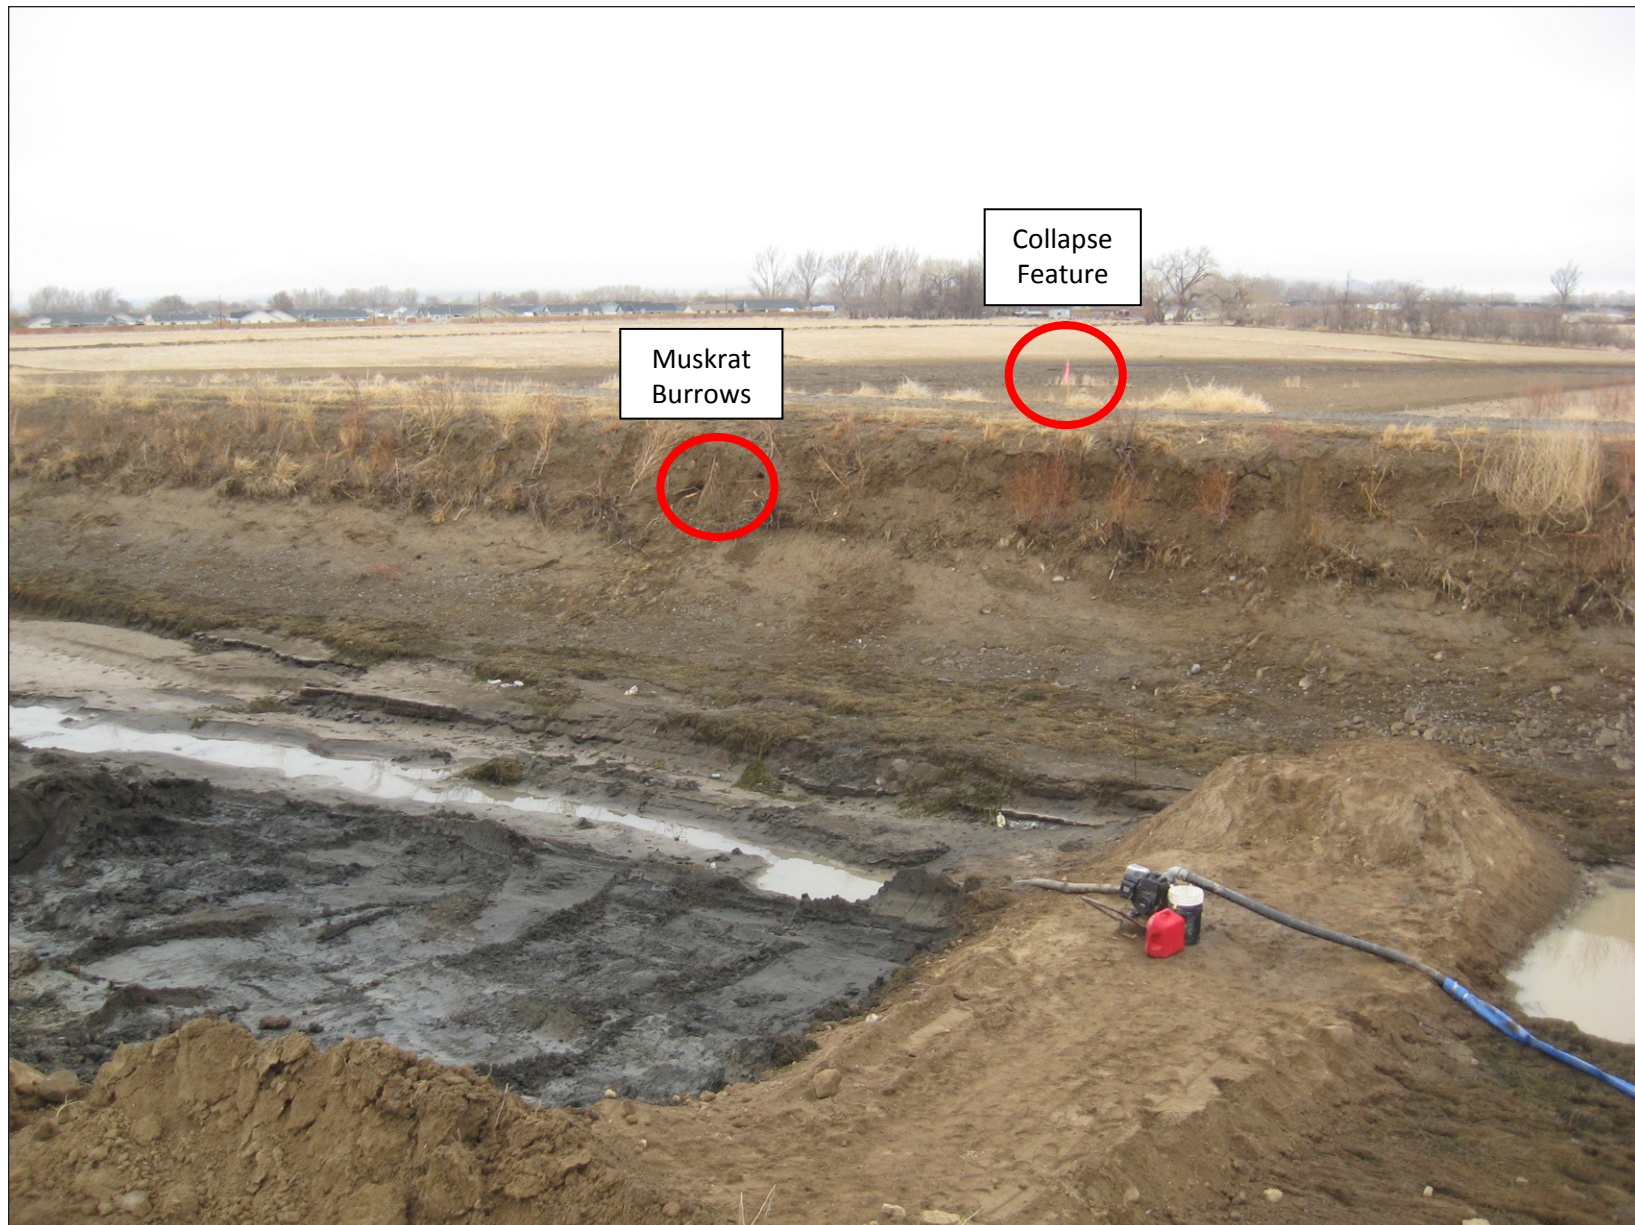
Photo 12. Canal bank looking north, showing relative position of muskrat burrows and collapse feature about 240 feet downstream from breach. Photo by M. McCulla, 01-14-2008.

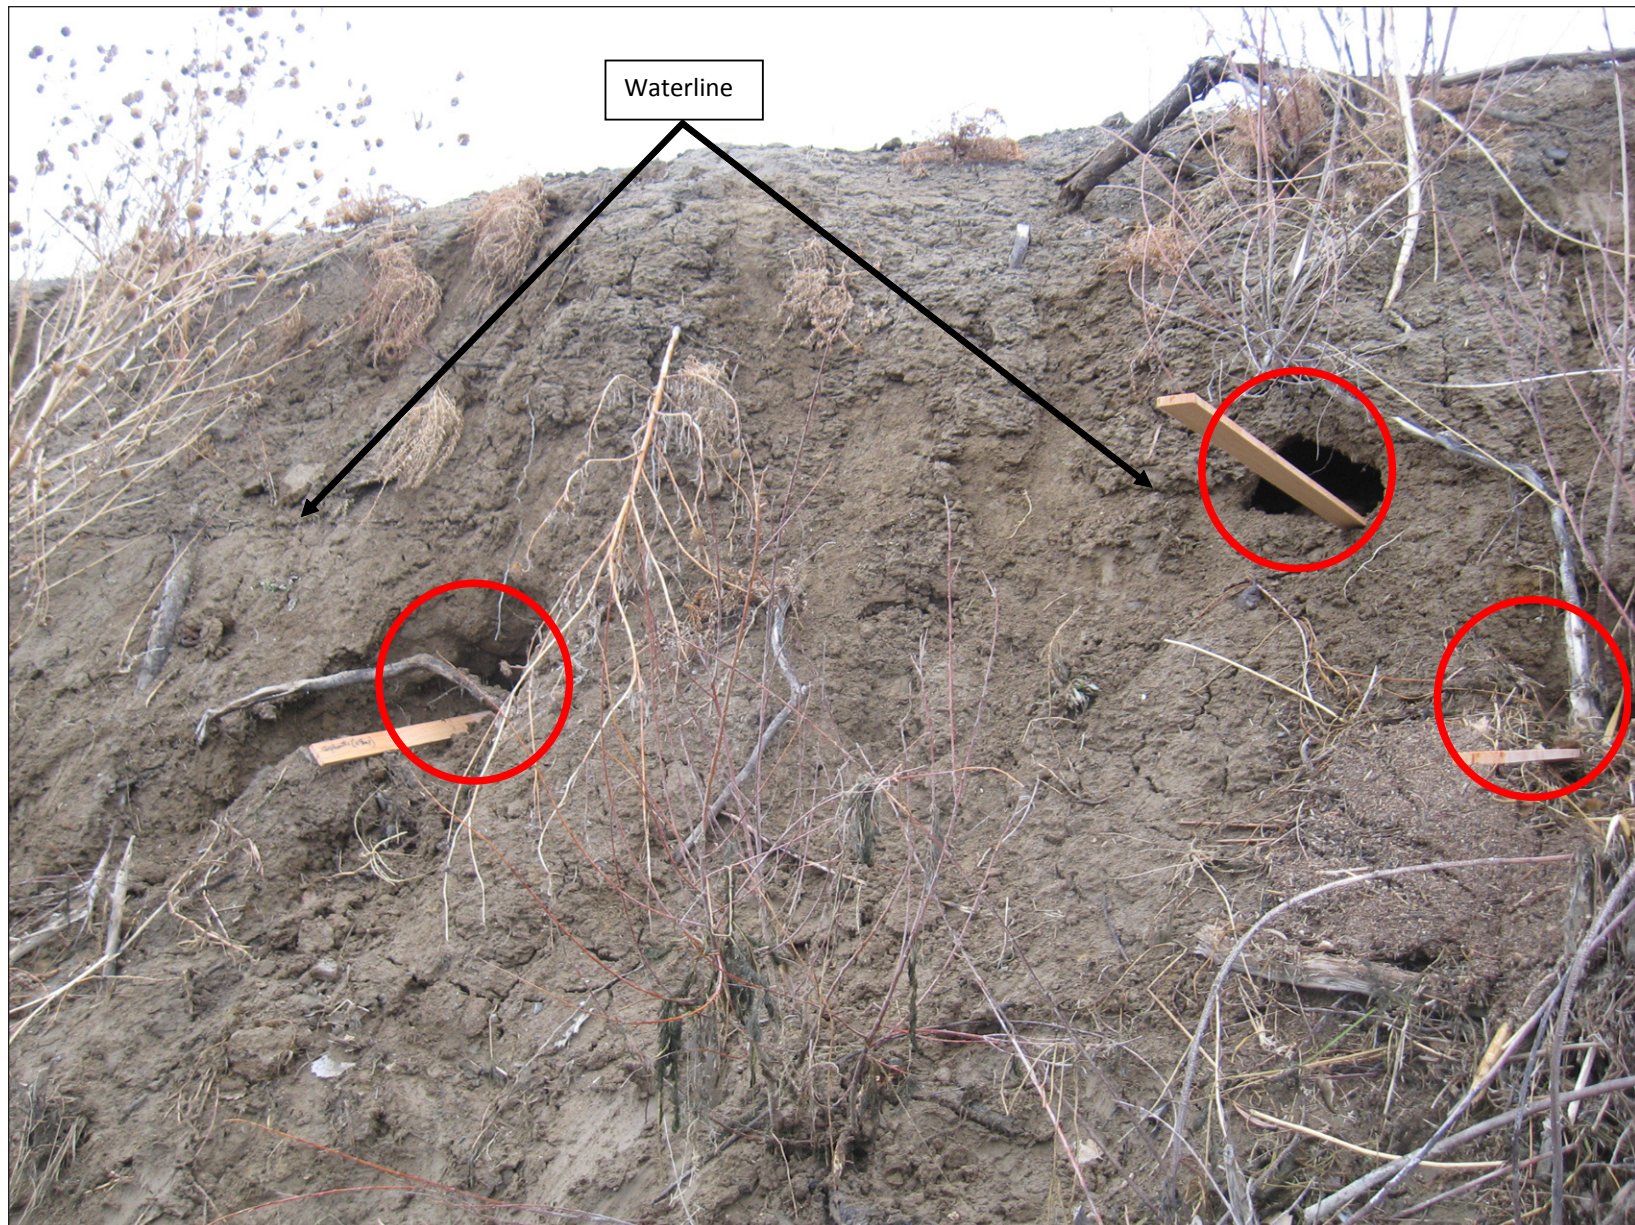
Photo 13. Three muskrat burrows across from collapse feature in left canal bank. Note high waterline in canal bank. Photo by M. McCulla, 01-14-2008.

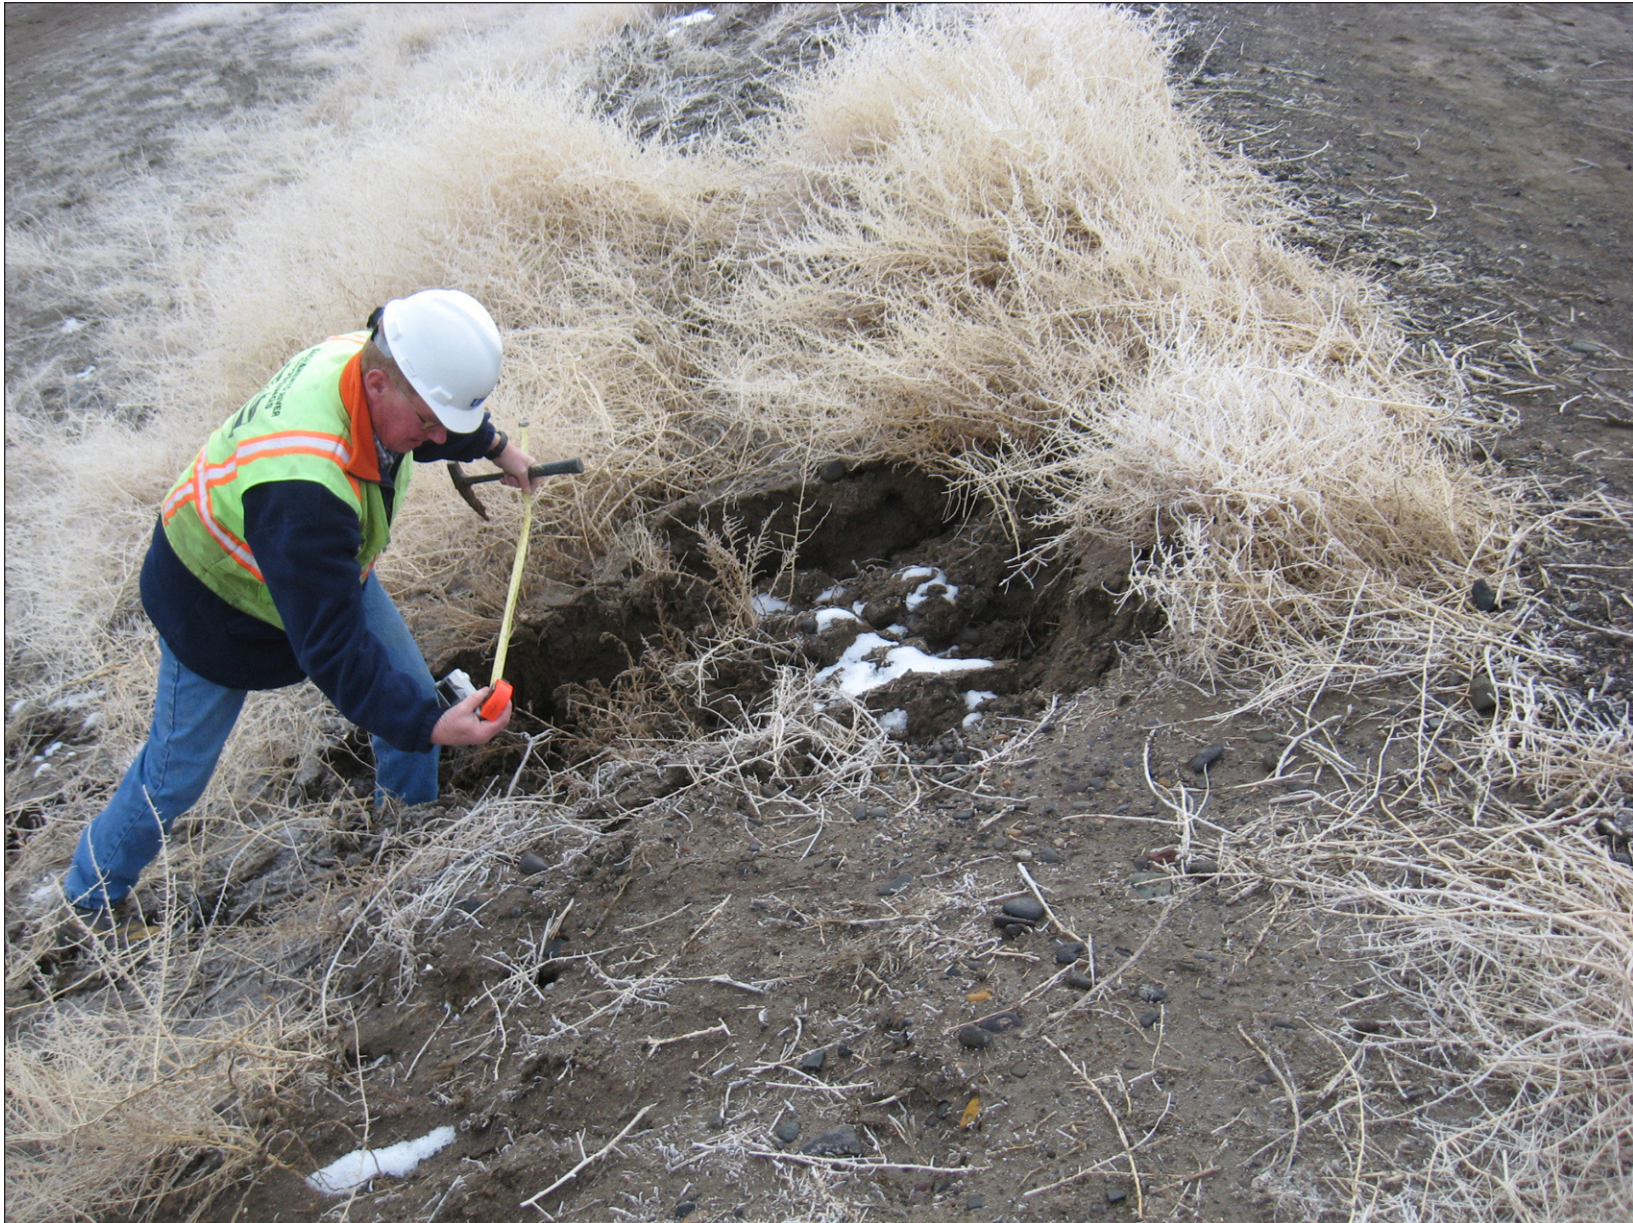
Photo 14. Landside, left canal bank, about 240 feet downstream from canal breach. Collapse feature associated with downhill sediment transport. Three muskrat burrows on the canal side of the embankment near high water line. Photo by M. McCulla, 01-13-2008.

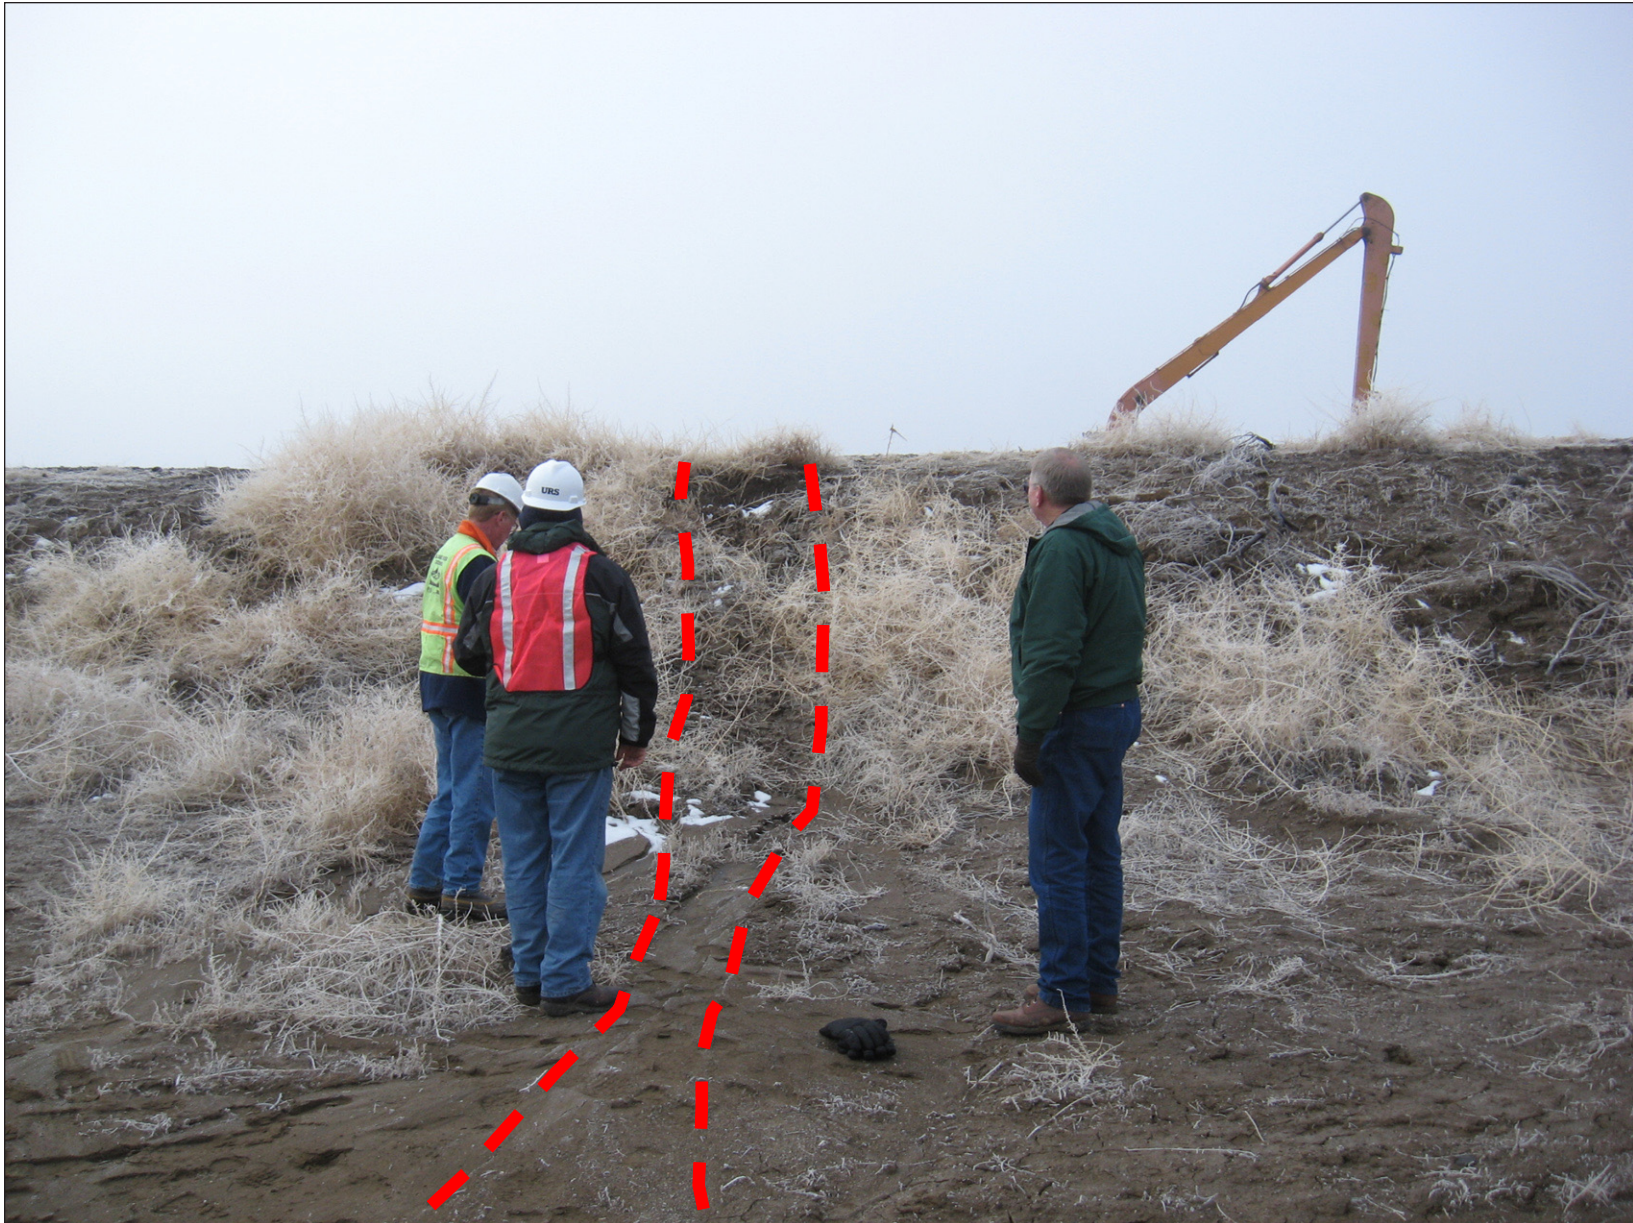
Photo 15. View from north side of canal looking towards collapse feature. Workers standing on sediment transported downhill from the collapse feature. Photo by M. McCulla, 01-13-2008.

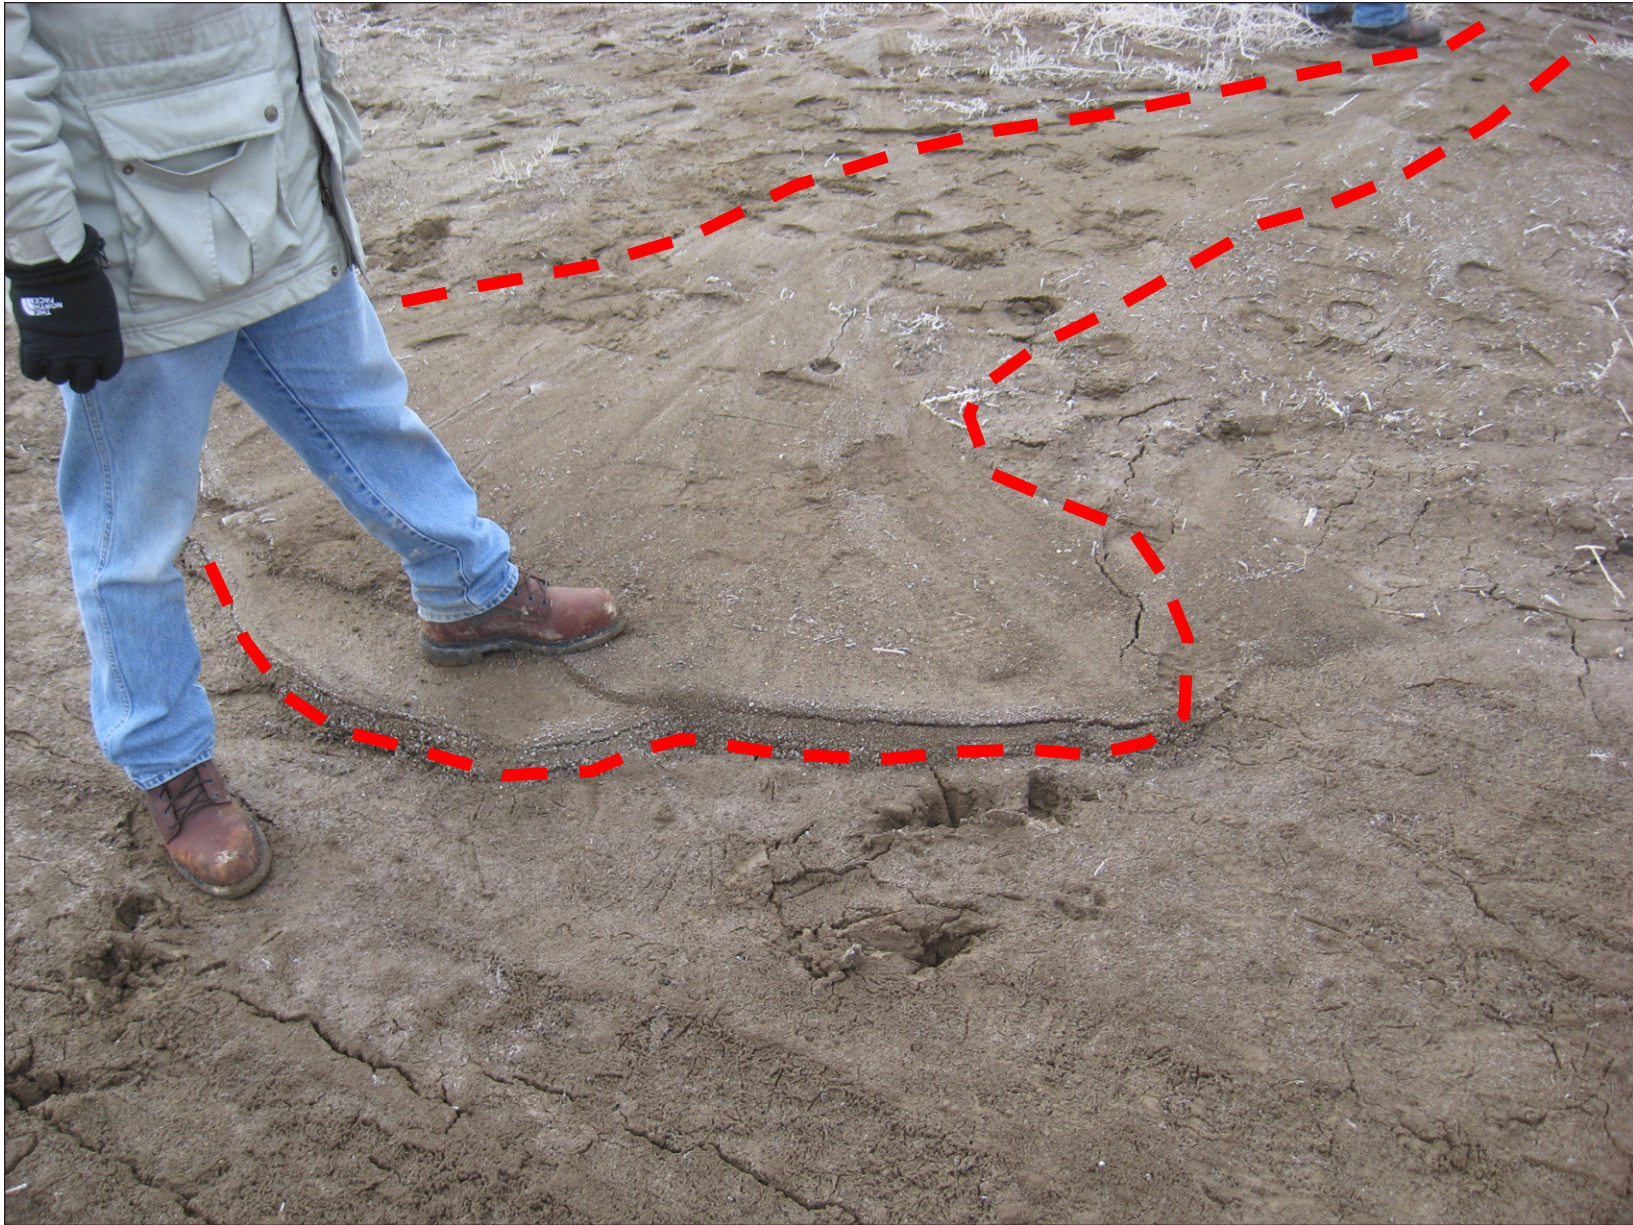
Photo 16. Small delta of sediment transported downhill from collapse feature. Photo by M. McCulla, 01-13-2008.

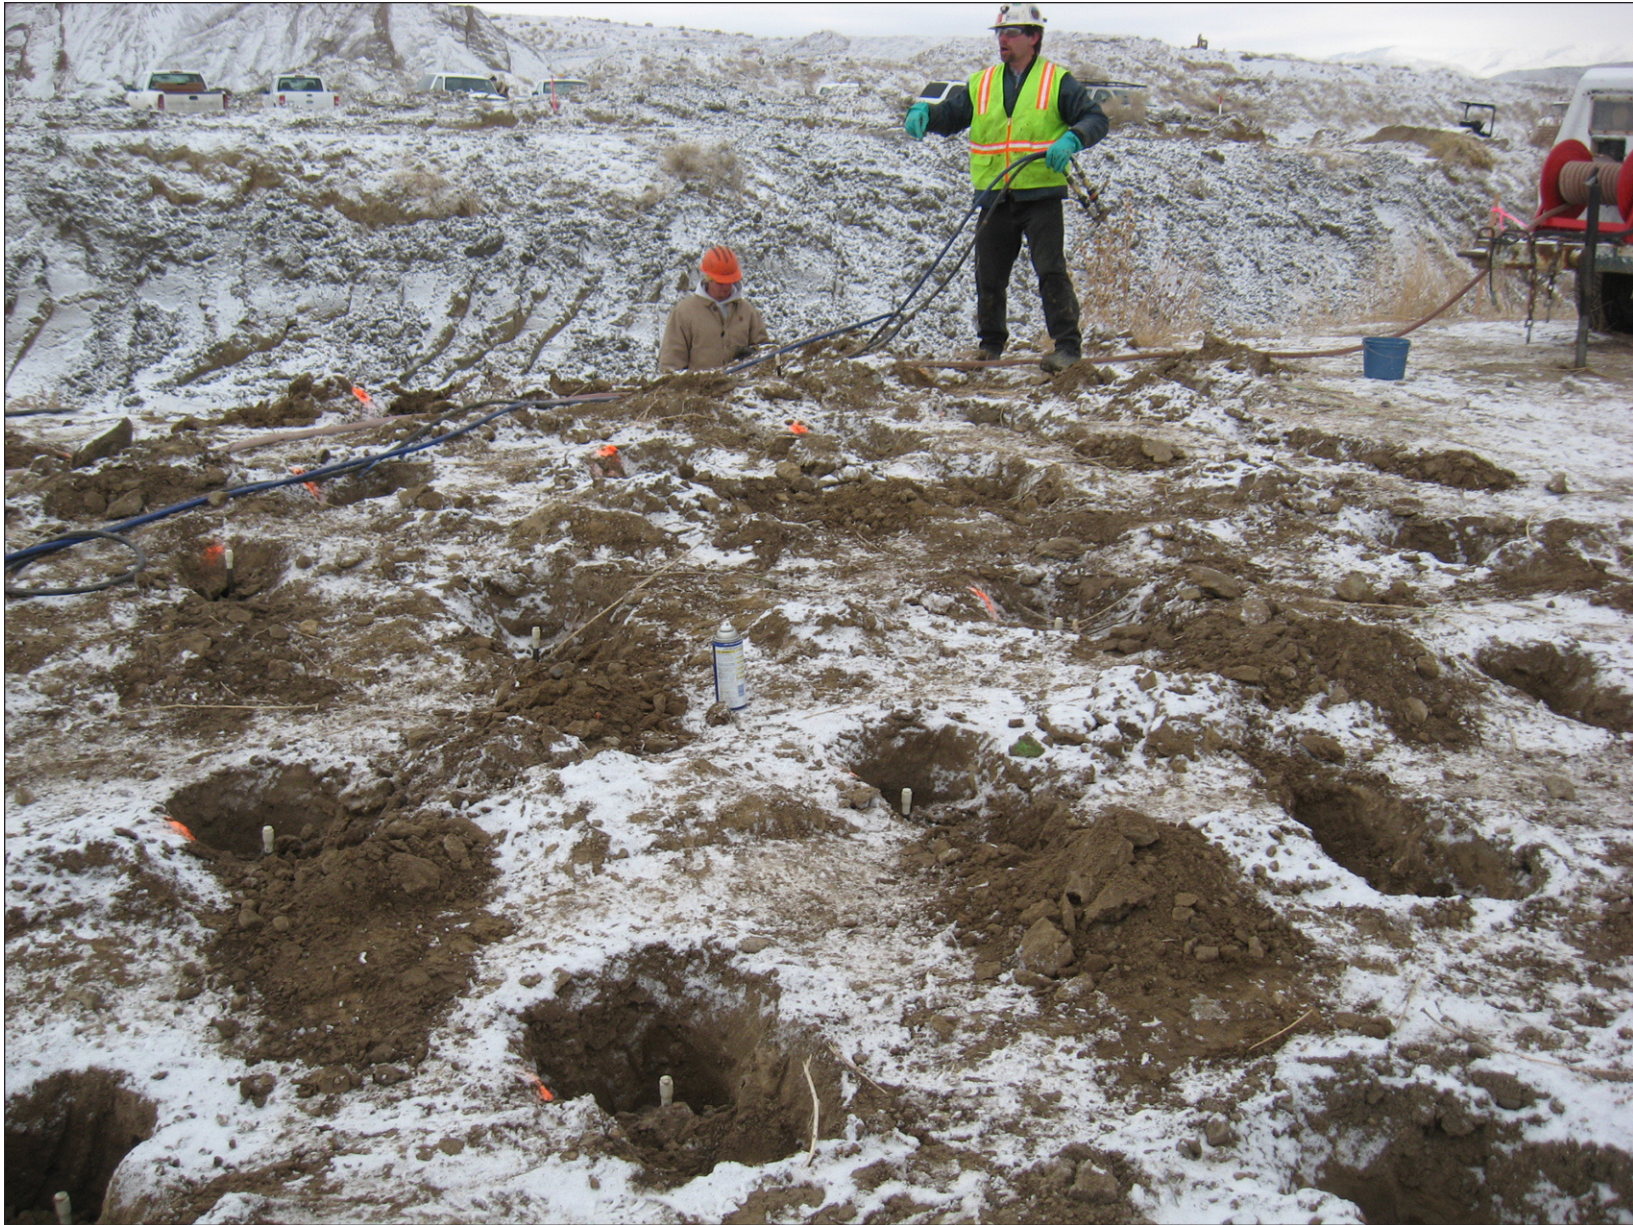
Photo 17. View of hollow-stem stratathane injection pipes. Worker is near location of the muskrat burrows on the canal side, and view is from area near collapse feature. Photo by M. McCulla, 01-22-2008.

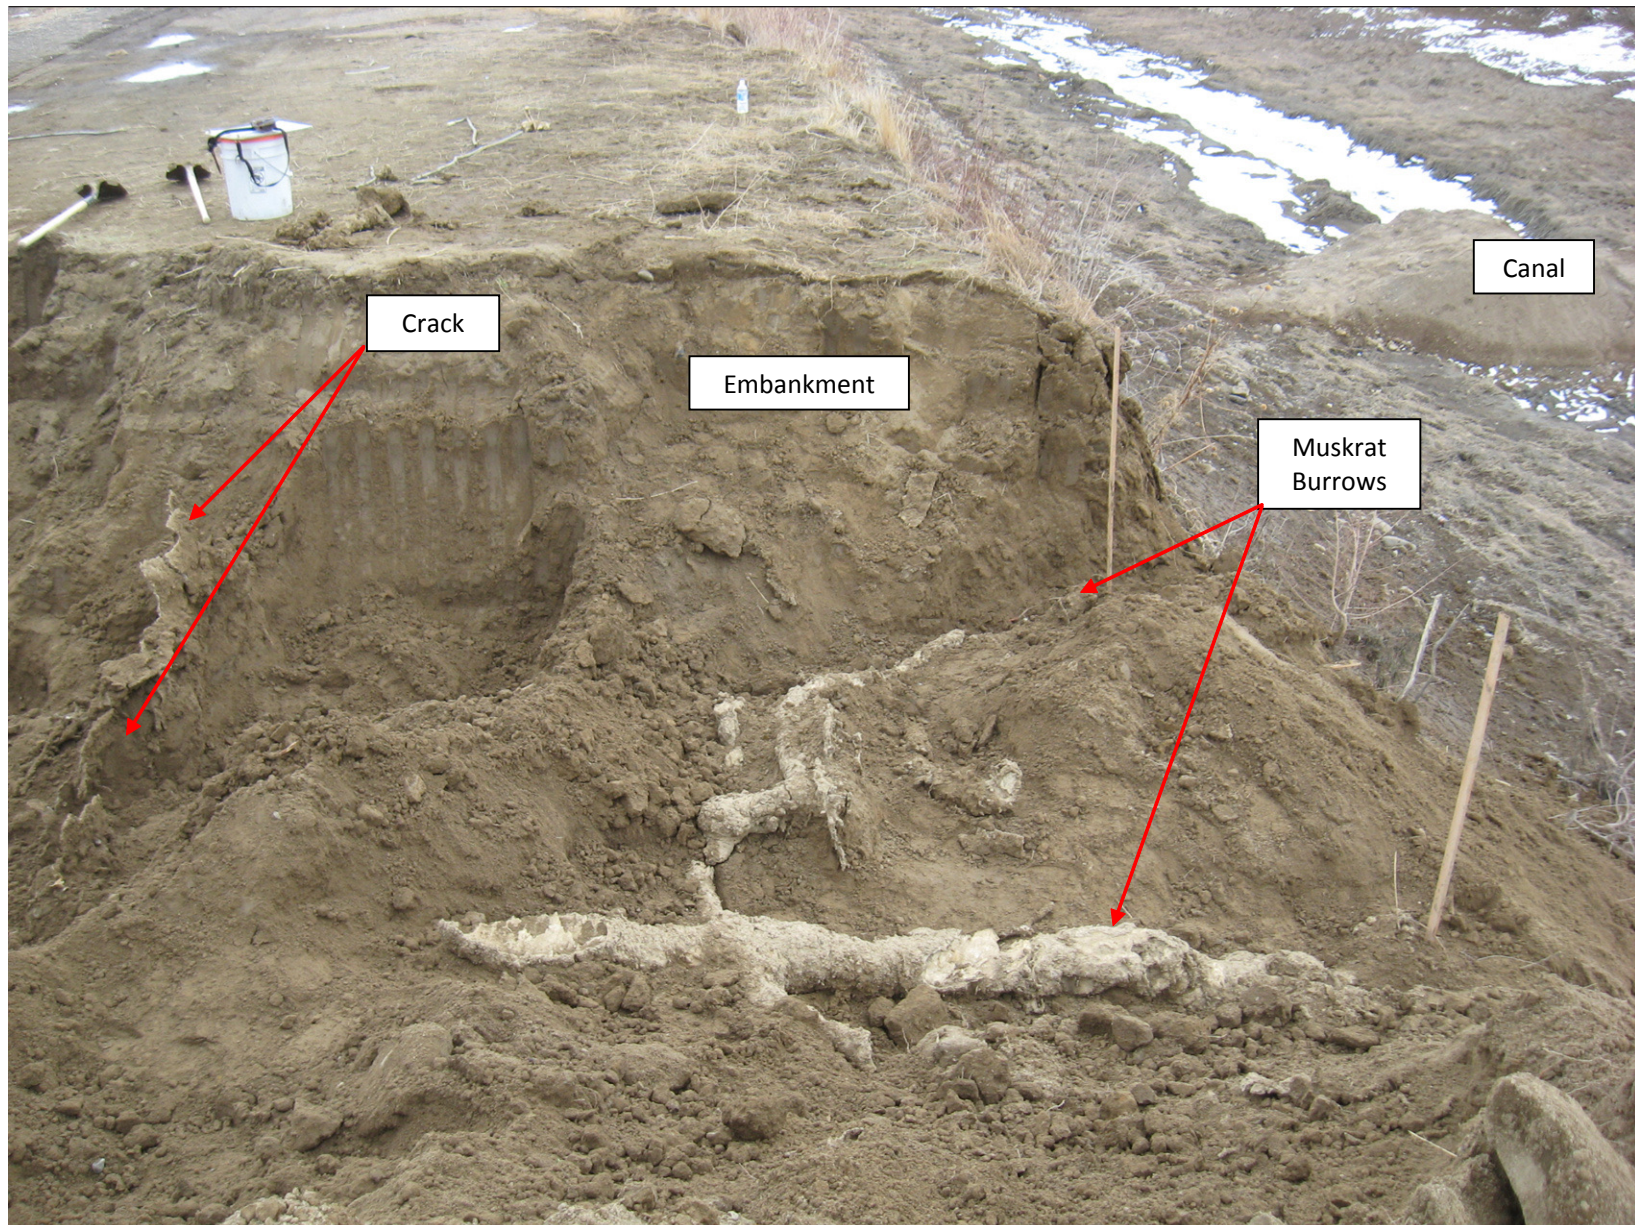
Photo 18. View of main muskrat burrows entering from canal. Note one of several cracks parallel embankment. Photo by M. McCulla, 01-23-2008.

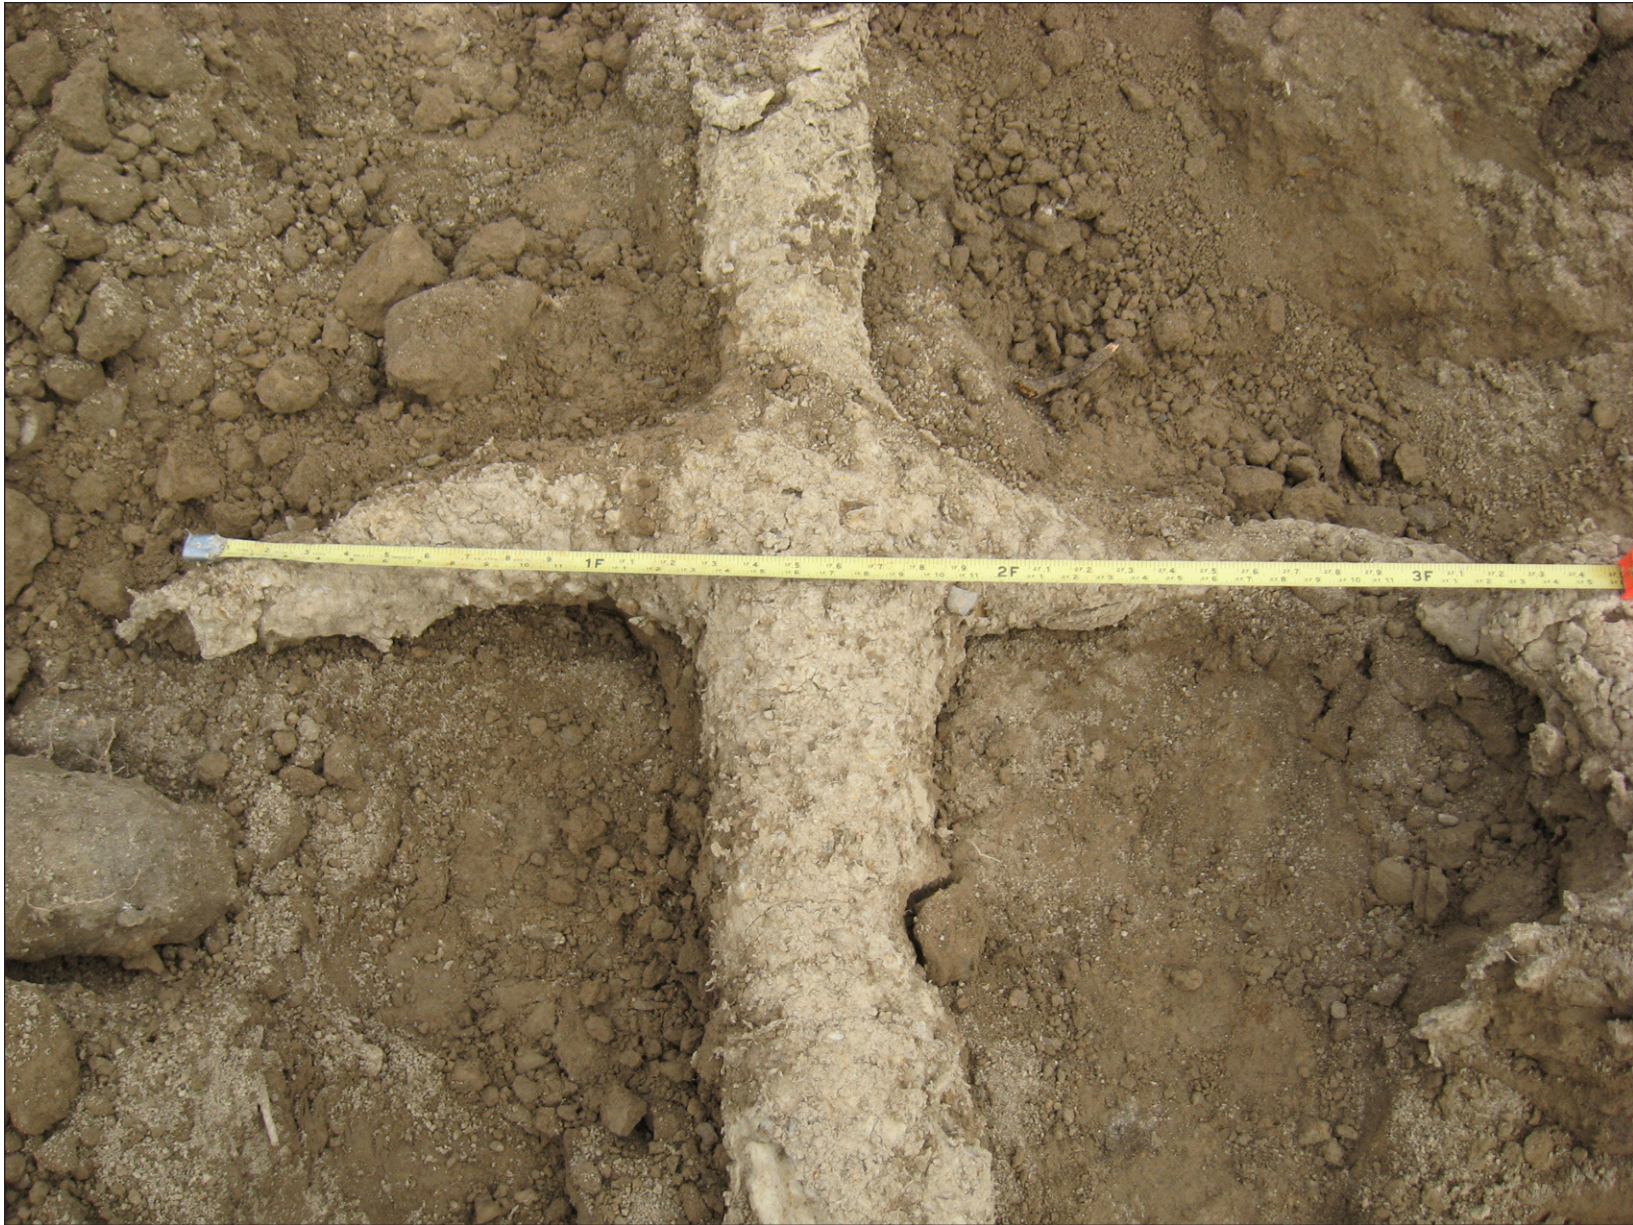
Photo 19. Close up of the main muskrat burrow. "T" structure shown is about nine feet in from canal. Photo by M. McCulla, 01-13-2008.

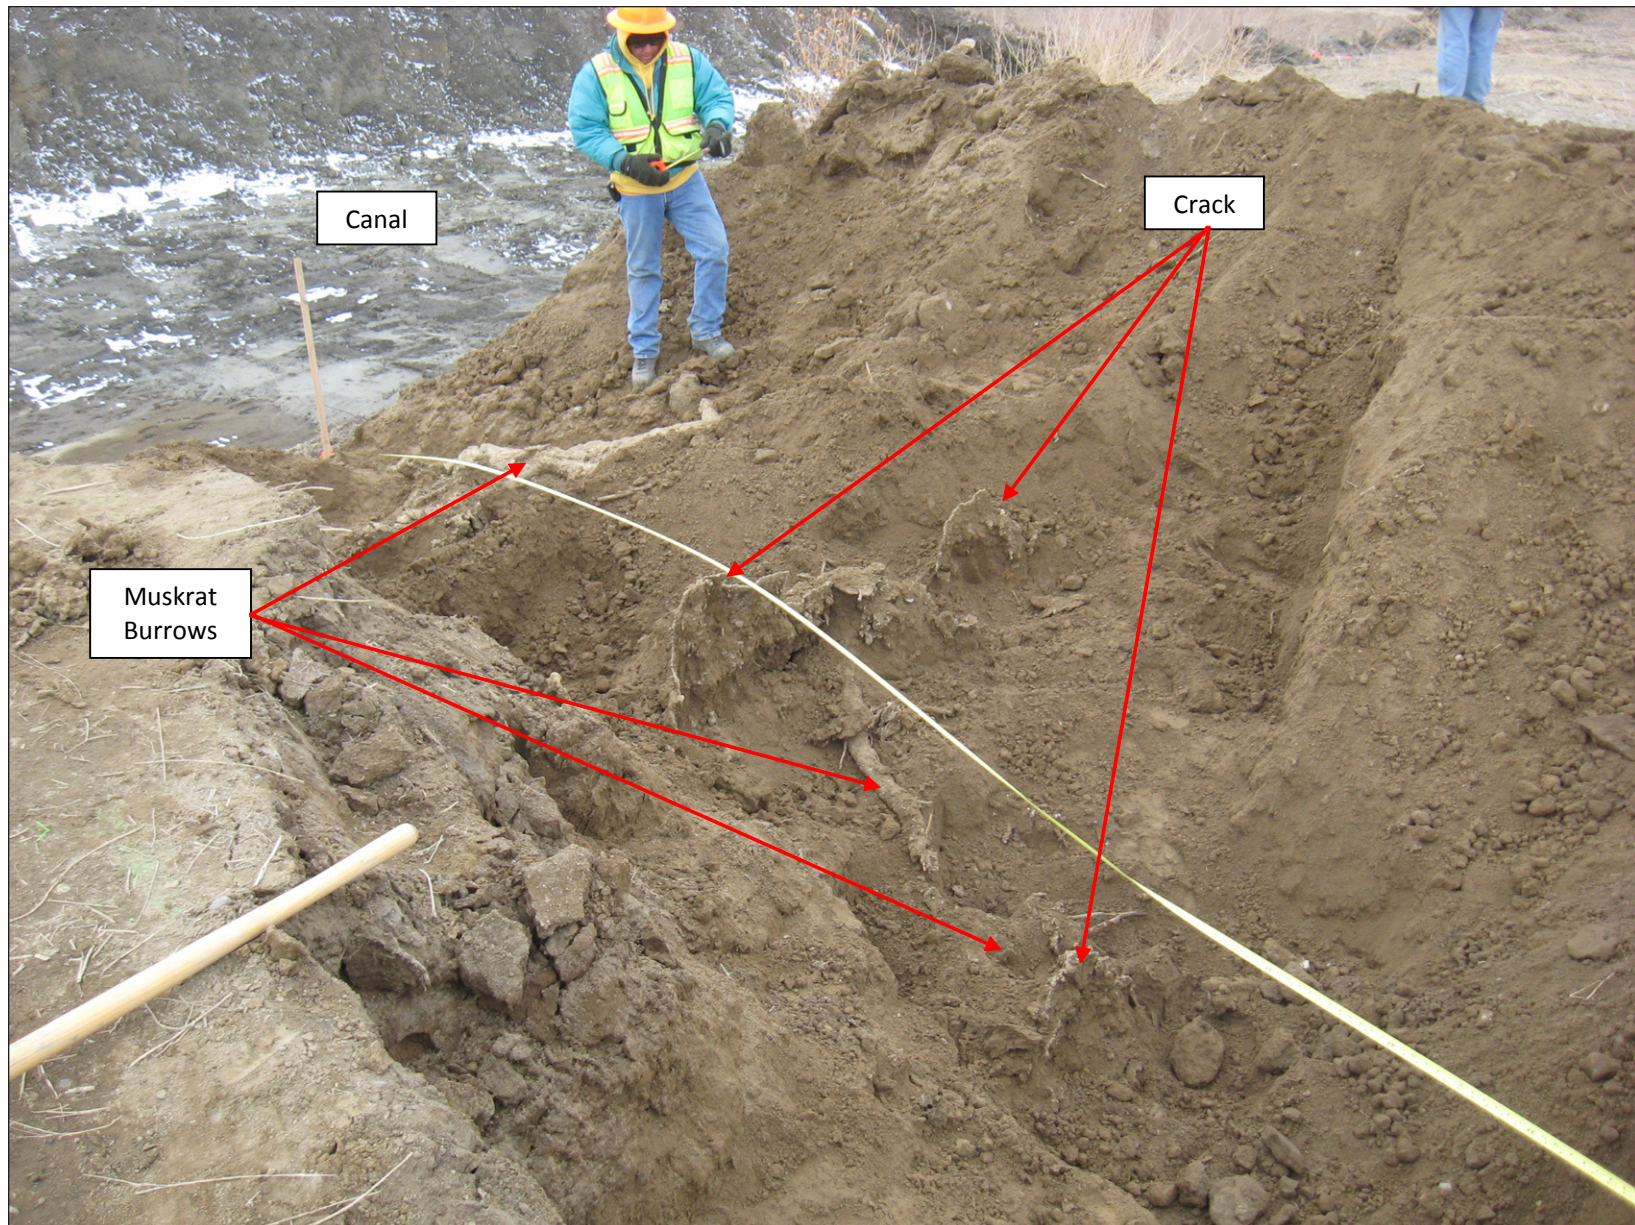
Photo 20. View towards canal showing muskrat burrows and cracks between canal and abandoned gas pipeline, 23 feet from canal.  
Photo by M. McCulla, 01-23-2008.

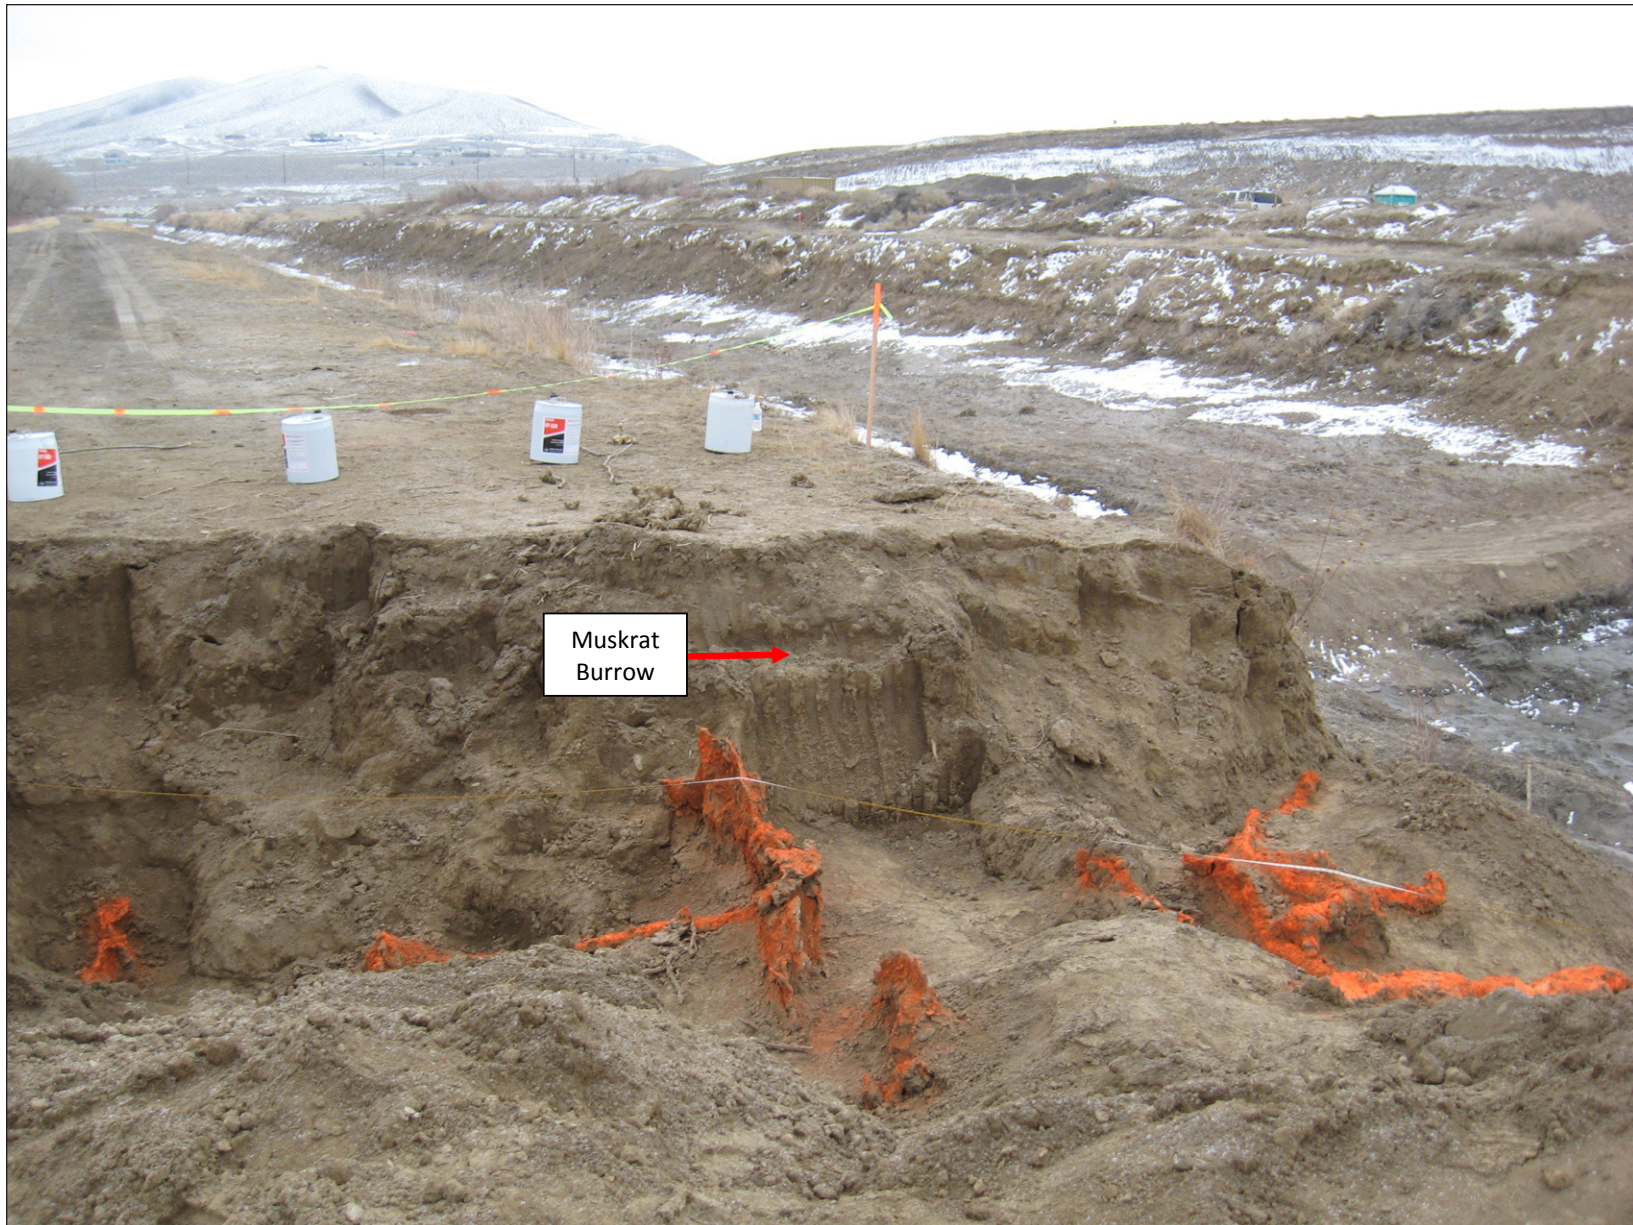
Photo 21. Downstream view of canal (right) and stratathane casts of muskrat burrows, cracks, and other voids painted orange. Photo by M. McCulla, 01-24-2008.
